ORNL/TM-7166

Corrosion of a Stainless Steel Waste Heat Recuperator

J. I. Federer
V. J. Tennery

Date Published: June 1980

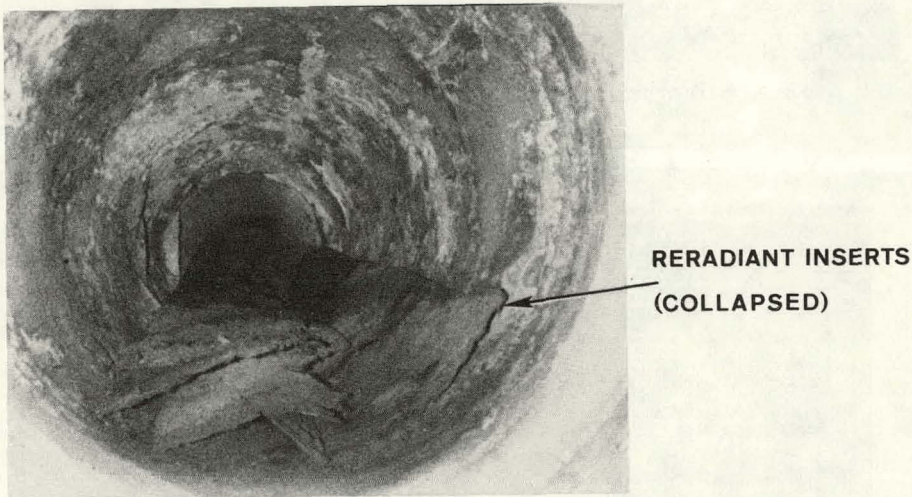
Fig. 3. View from bottom of recuperator after removal from furnace.

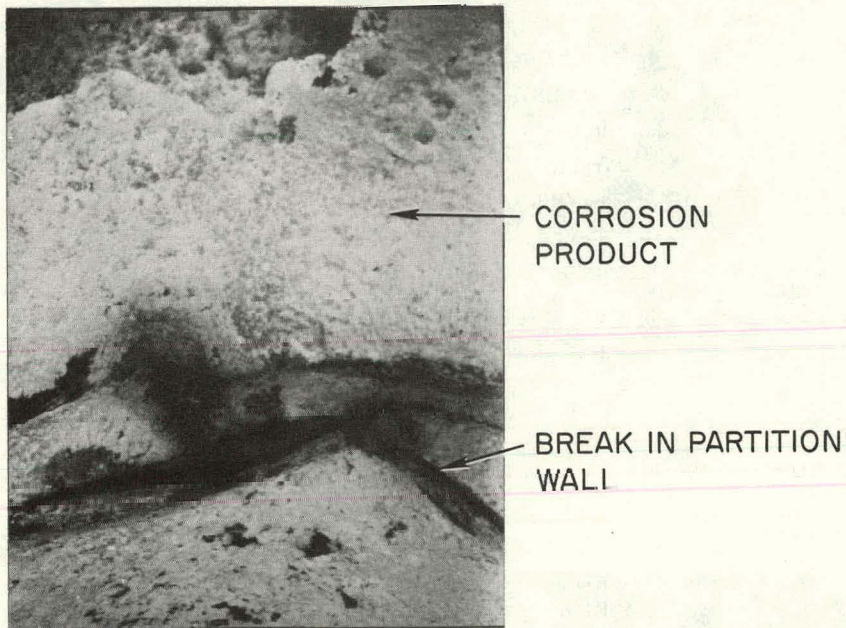
- An irregular-shaped hole occurred in a distorted area ~ 4.9 m (~ 16 ft) from the bottom.
- Thick corrosion products occurring on the wall and reradiant inserts were light gray above the hole and dark gray below the hole.
- Severe corrosion occurred on the reradiant inserts at the bottom end, with substantial loss of material.
- The Incoloy 800 H angle brackets on the reradiant inserts were severely corroded; in fact, some were completely disintegrated.
- Discoloration on the outer wall approximately adjacent to the hole in the partition wall indicated that excessive temperatures occurred at that location.

Fig. 4. Break in partition wall about 4.9 m from bottom of recuperator.

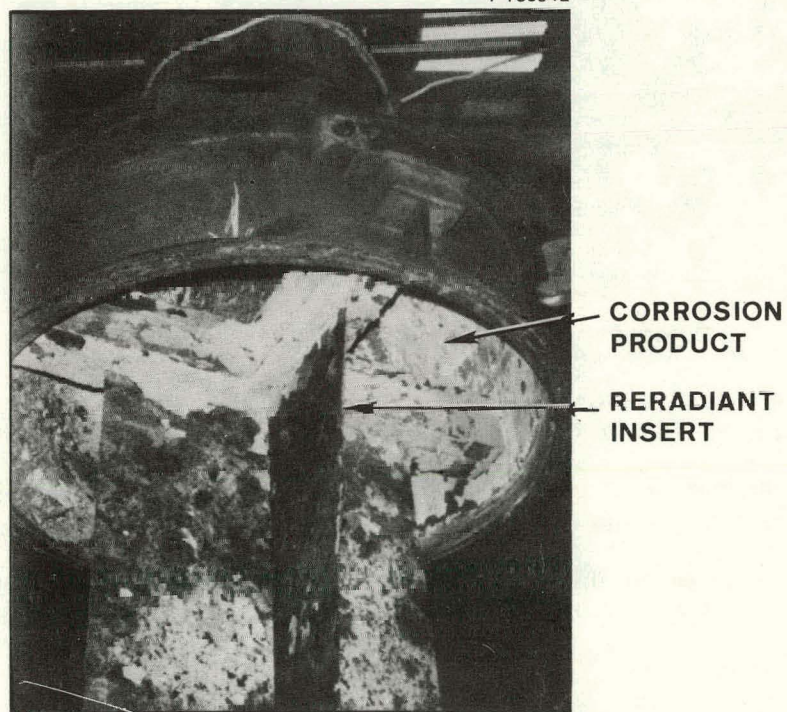
Fig. 5. Dome and reradiant inserts at top of recuperator.

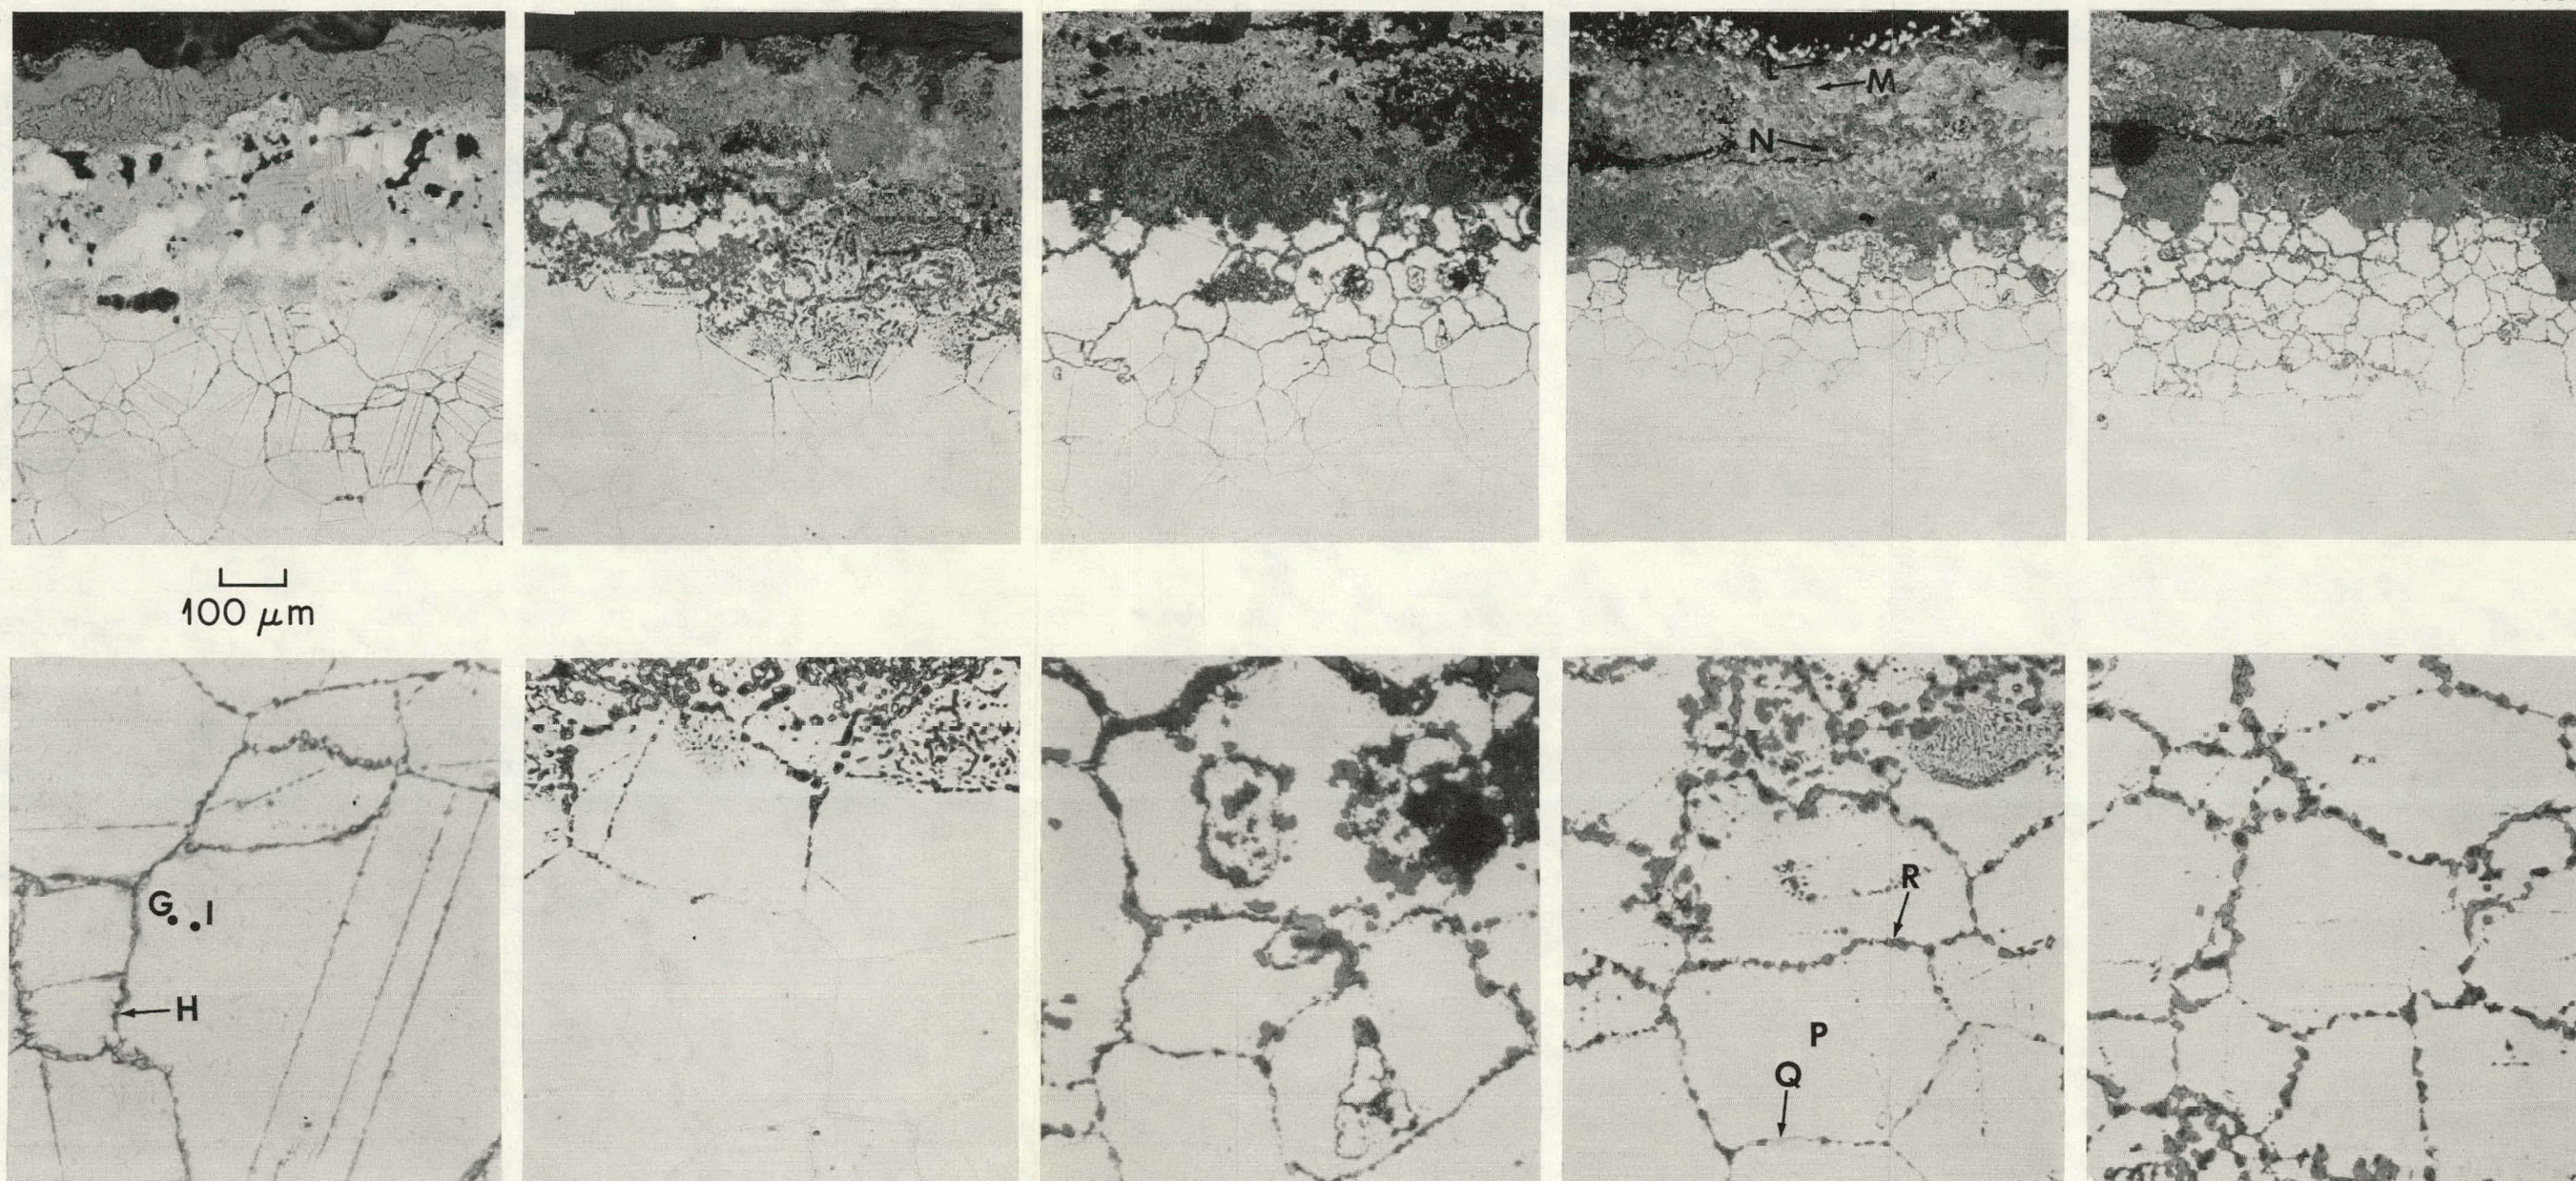
Samples of the reradiant insert were mounted and polished so that the corrosion product and base metal could be examined in a plane perpendicular to the surface. Figure 7 shows polished (unetched) sections of the corrosion product and base metal of the reradiant inserts at intervals along the height of the recuperator. The corrosion product, or surface scale, appears to be a nonhomogeneous mixture of compounds and porosity. Cracks in the scale were probably caused by temperature variations coupled with differences in thermal expansion between the scale and alloy, and these cracks eventually caused spalling of the scale. The scale had apparently spalled from sample RI-3A because the scale plus the base metal were only ~ 0.9 mm thick at this location (~ 0.9 m from the bottom of the recuperator). Since the reradiant insert was ~ 5 mm ($3/16$ in.) thick, corrosion had consumed $>80\%$ of the original thickness.

The main feature of the base metal, as shown in Fig. 7, is the extensive intergranular attack below the surface scale. The attack is clearly visible even though the samples are not etched. Intergranular corrosion appears to completely isolate grains, resulting in gradual disintegration of the base metal. The grain boundaries of sample RI-3B contained a precipitate which is clearly visible in Fig. 7. The nature of this precipitate and other characteristics of the corrosion product and base metal will be discussed.

Fig. 7. Polished sections of reradiant insert at intervals showing corrosion product and intergranular attack of alloy.

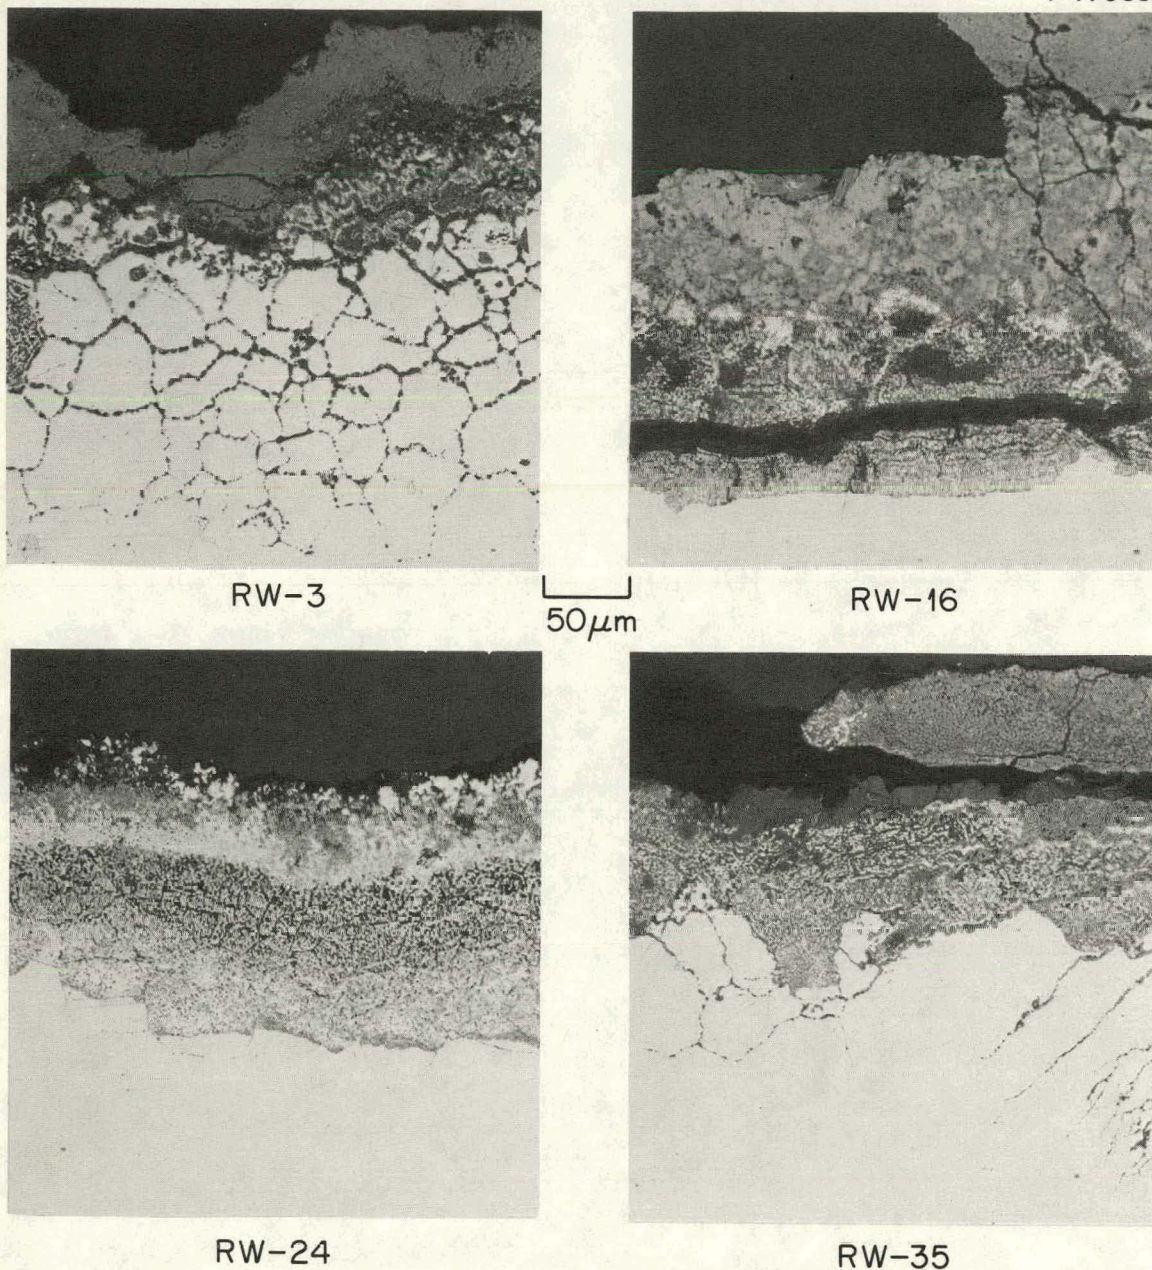
The microstructure of the partition wall at intervals along the height of the recuperator is shown in Fig. 8. The appearance of these samples is similar to that of the inserts, being characterized by a surface scale and intergranular corrosion of the base metal below the scale. Figures 7 and 8

Fig. 8. Polished sections of partition wall at intervals, showing corrosion product and intergranular attack of alloy. Distance from bottom of recuperator: RW-3, 0.9 m; RW-16, 4.9 m; RW-24, 7.3 m; RW-35, 10.7 m.

clearly show that corrosion occurred over the entire height of the recuperator and that the same corrosion process was operating at all locations.

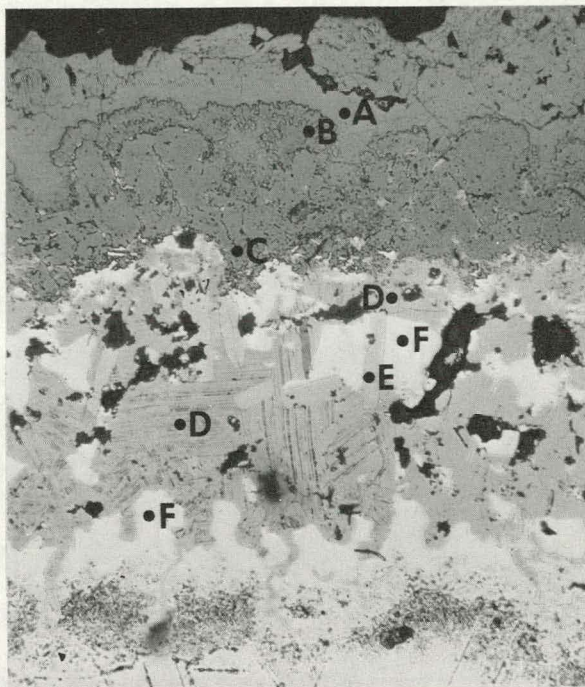
The distribution of elements in the corrosion product and the base metal was determined with an electron microprobe. The corrosion product on sample RI-3A, which was ~ 0.9 m from the bottom of the recuperator, is shown in Fig. 9. Characteristic x-ray spectra for regions *A* to *F* in Fig. 9 are shown in Figs. 10 to 15. The relative peak heights in Figs. 10 to 15 indicate the relative

Fig. 9. Corrosion product on sample RI-3A located ~ 0.9 m from bottom of recuperator.

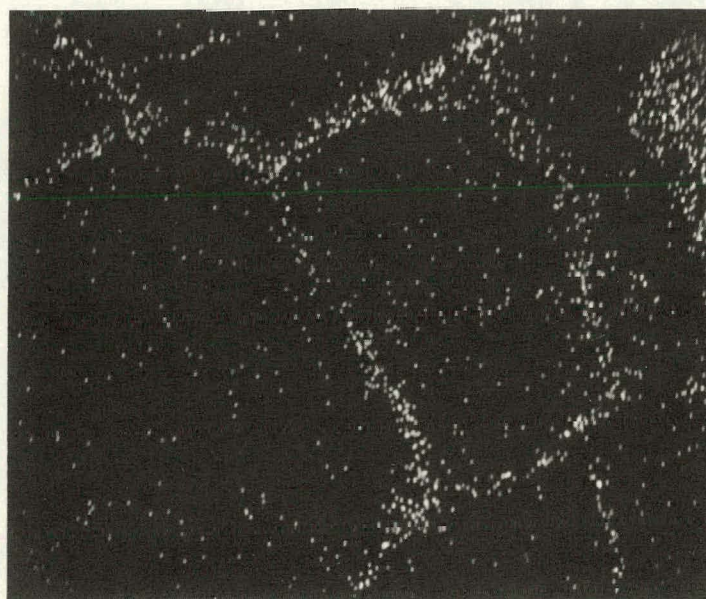
Fig. 18. Characteristic x-ray display in sample RI-3A, showing chlorine at the grain boundaries.

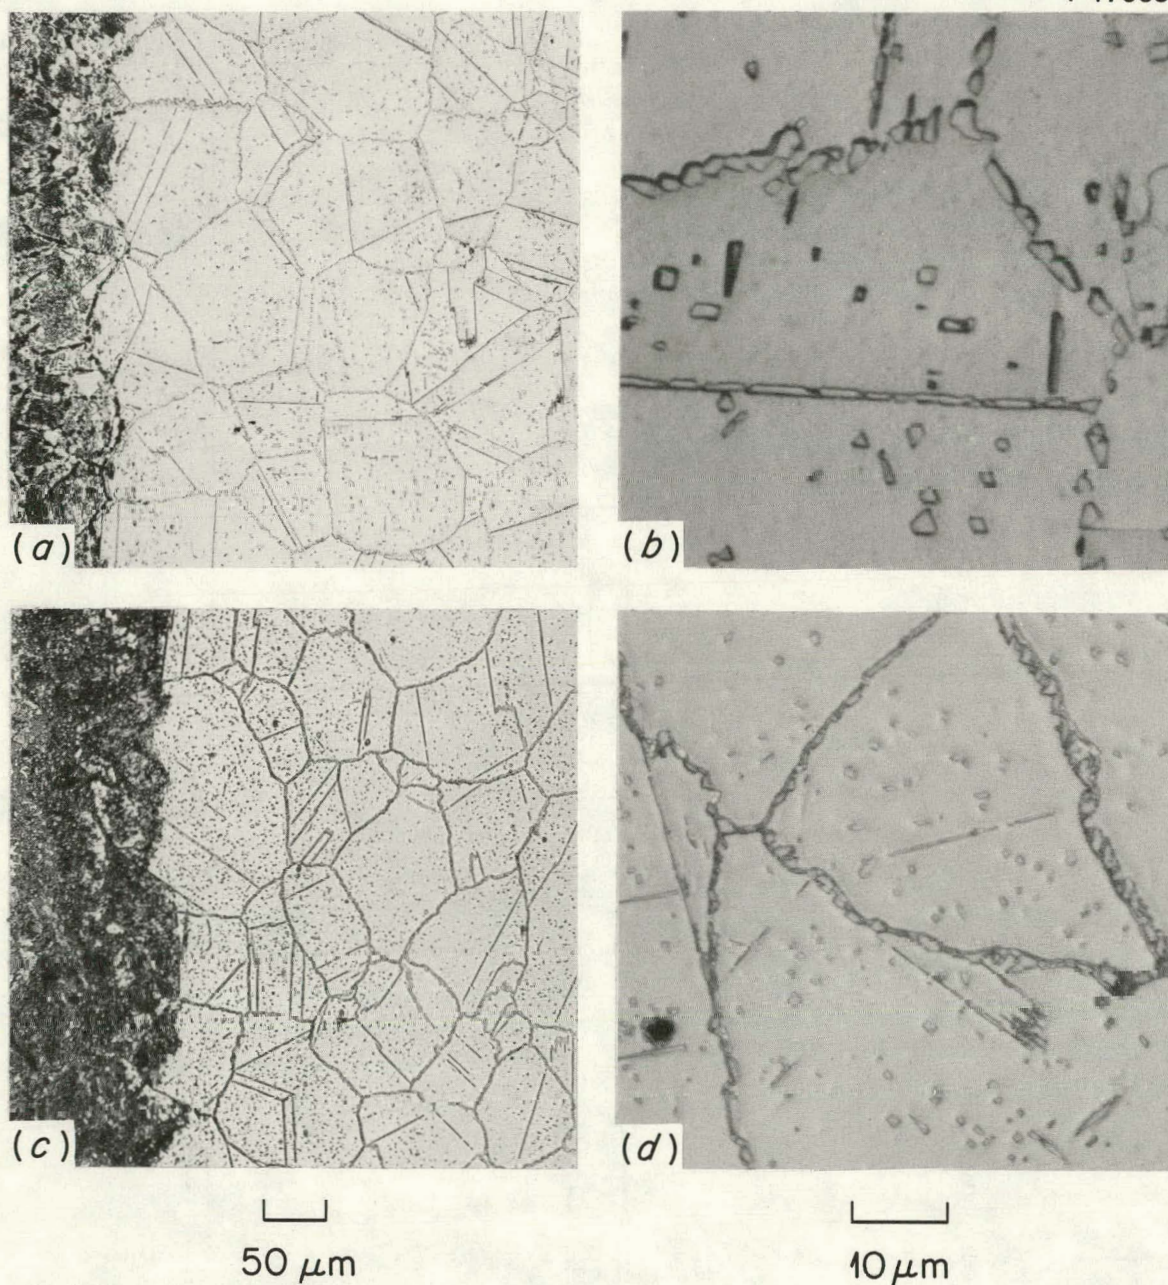
Fig. 21. Microstructure of samples of reradiant insert. (a) RI-3A, 200X; (b) RI-3A, 500X; (c) RI-3B, 200X; (d) RI-3B,

The amount of carbide precipitation is not consistent with the carbon content of the original type 309 stainless steel, which was only $\sim 0.07\%$. The samples have apparently been carburized by exposure to fuel-rich combustion products. Stainless steels can be carburized by heating in an atmosphere containing hydrocarbon compounds or carbon monoxide. Oil vapors, of course, would contain carbonaceous compounds. In the case of austenitic stainless steels, carburization is particularly detrimental if the carbon is subsequently precipitated as carbide. Much of the carbon combines with chromium to form chromium carbide, Cr_{23}C_6 , and the adjacent matrix, depleted in chromium, is less resistant to corrosion in many environments.

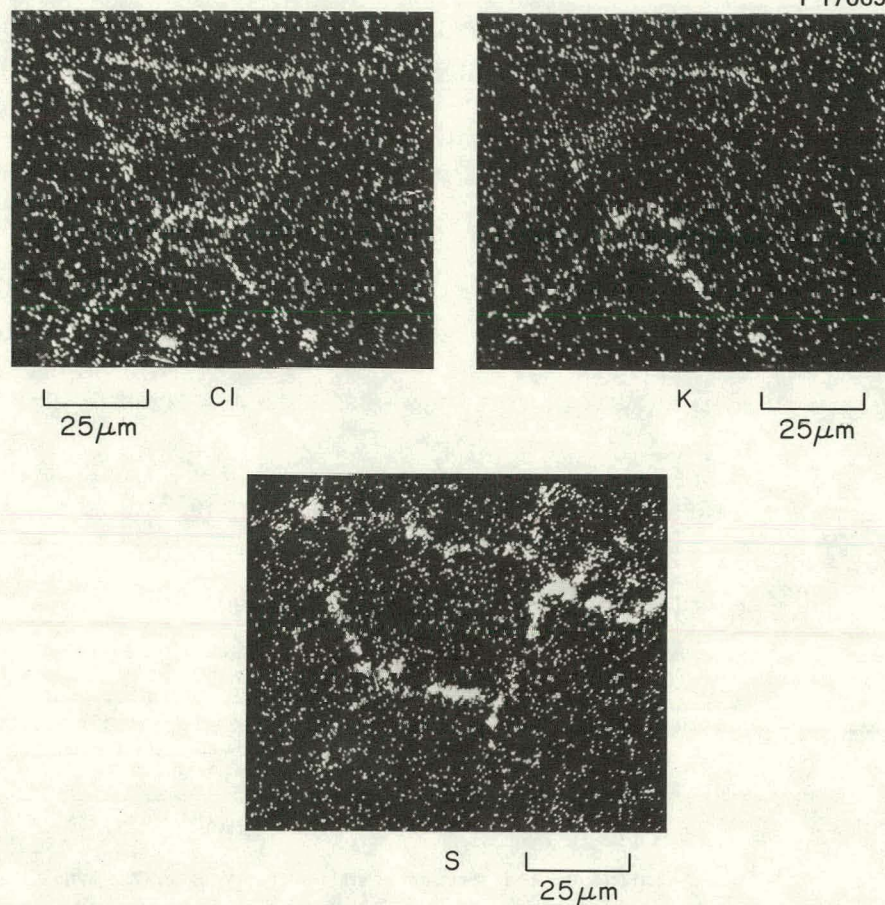
Fig. 28. Characteristic x-ray displays for Cl, K, and S in sample RI-24.
